Resource Bulletin PNW-300
May 1971

MASS MOVEMENT RESPONSE TO FOREST MANAGEMENT IN THE CENTRAL OREGON COAST RANGES

By Stuart Gresswell • David Heller • Douglas N. Swanston

Gresswell, Stuart, David Heller, and Douglas N. Swanston.
1979. Mass movement response to forest management in the
central Oregon coast ranges. USDA For. Serv.
Resour. Bull. PNW-84, 26 p., illus. Pacific
Northwest Forest and Range Experiment Station,
Portland, Oregon.

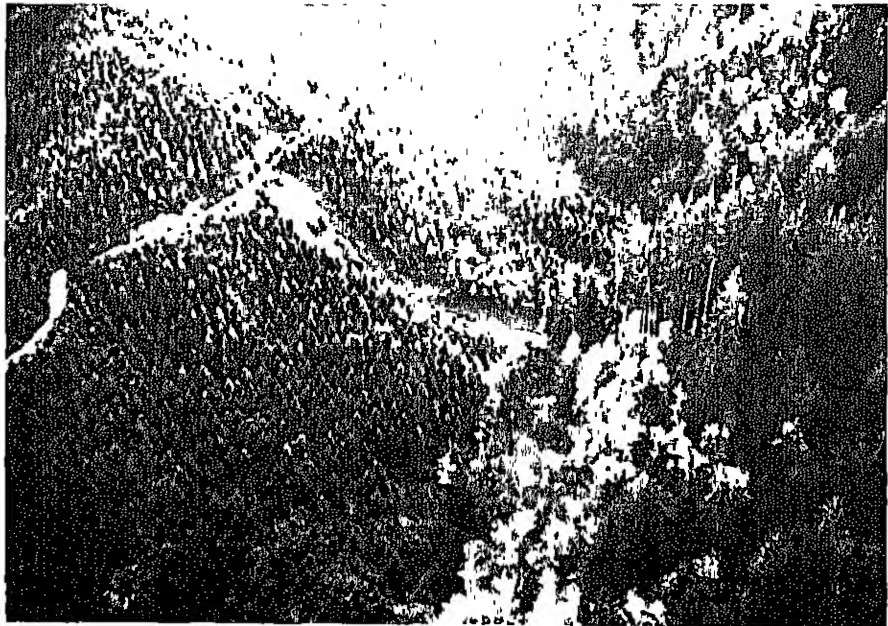
Figure 4.--Debris
avalanche
resulting from
a road prism
failure.

Information on an event was recorded on a standard data sheet (fig. 2). Slides were first placed in one of three major categories: natural, road-related, or in-unit. Natural slides were those events which had no apparent relation to management activity (fig. 3). Road-related failures were those failures which occurred within the road prism or had an obvious connection to the road (fig. 4). Typically, those were from a concentration of drainage water by ditchline and culvert outfalls or by ditchline obstruction. Slides occurring at the edge of landings were considered road related. Those which occurred within the boundaries of clearcut units and had no apparent relation to roads or landings were in-unit slides (fig. 5).

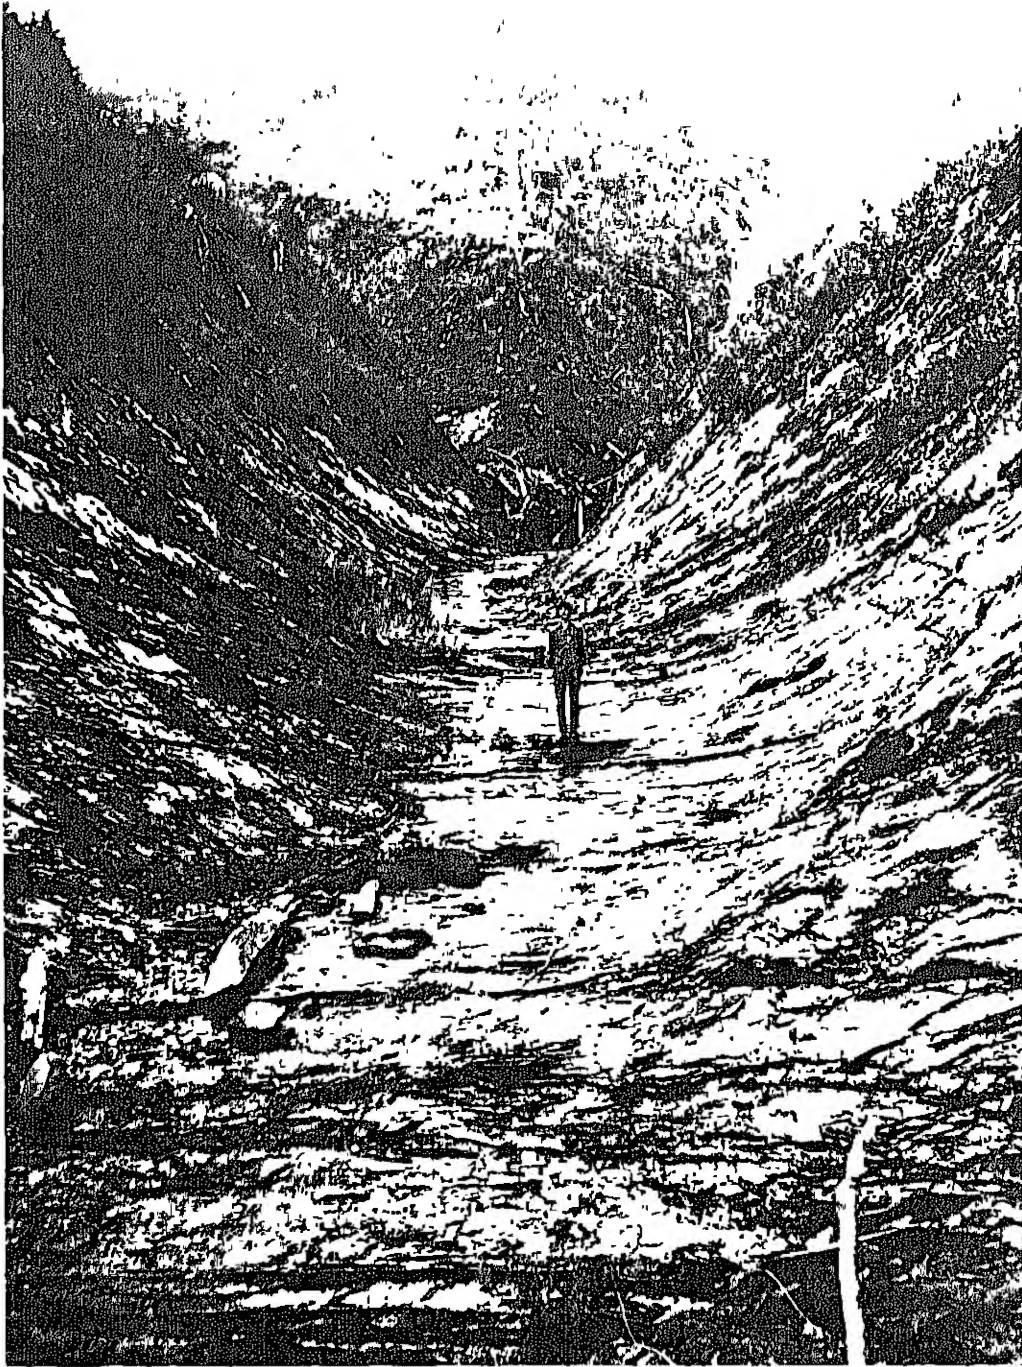
Figure 7.--Channel scour in a class I stream result from a debris torrent.

Mechanical scouring was the clearest impact to identify and define during the inventory (figure 7). It was possible to correlate scour directly with failure category. Thus, of the total length of channel scour observed (91,236 feet or 17.28 miles), 52 percent (47,395 feet or 8.98 miles) occurred as the result of in-unit failures. Road related failures accounted for 29 percent of about 26,140 feet (4.95 miles) of scour. Natural failures produced 19 percent or 17,700 feet (3.35 miles) of scour. All of these channel scour estimates are conservative.
